Leak Report

Project Info

Project Name: HAVA KACAK RAPORU
Customer: XXXXXXXX
Address: XXXXXXXX
54400 SAKARYA
TURKIYE
Start Date: 2022-06-22
End Date: 2022-06-28

Project Summary

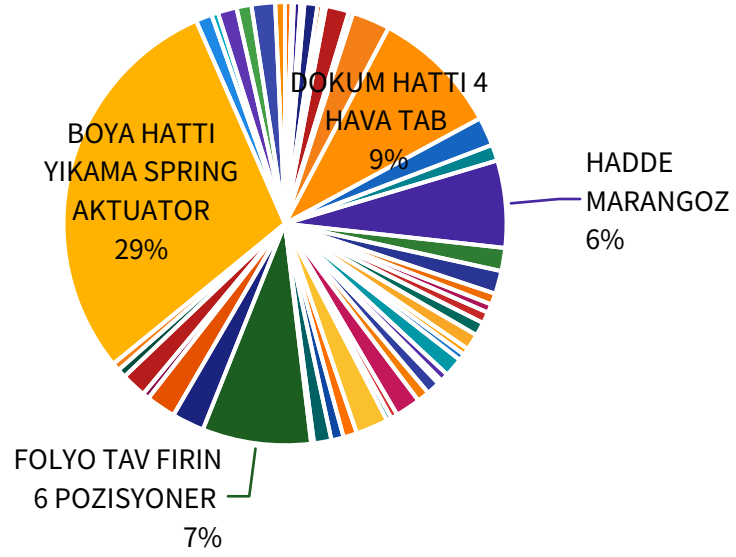
Leak losses by location

Location	Number of leaks	Leak losses(l/min)	Leak costs(EUR)
KOMP DAIRESI	1	2.60	26
TASLAMA MAK BESLEME	1	0.20	2
TASLAMA PRES ELUMATEC	1	0.60	6
FREZE SARTLANDIRICISI	1	2.60	26
TASLAMA TEST MAK MOTOR KABINI	1	1.50	15
TASLAMA TEST UNITESI PISTON	2	5.10	51
HIDROLIK BAKIM TEKER SISIRME UNITE	1	1.90	19
HIDROLIK BAKIM TORNA ATOLYESI	1	1.40	14
DOKUM 1 HAVA TAB	1	9.00	91
SERAMIK ATOLYE HAVA TAB	1	1.70	17
HIDROLIK UNITE VALF	1	14.80	149
DOKUM HATTI 4 HAVA TAB	3	50.10	505
DOKUM HATTI 4 HAVA TAB	1	11.20	113
DK5 FILTRE ALT TAHLIYE	1	6.30	64
HADDE MARANGOZ	1	34.00	343
HADDE MARANGOZ	1	9.00	91
HADDE SARTLANDIRICI ALTI	1	9.00	91
FOLYO HADDE1 RAKOR BAKANTI	1	4.40	44
FOLYO HADDE 1	1	3.40	34
FOLYO HADDE1 HAVA HATTI	1	4.40	44

Location	Number of leaks	Leak losses(l/min)	Leak costs(EUR)
FOLYO HADDE 1 T BAGLANTI	1	5.30	53
TAV FIRINLARI SOLENOID VALF	1	6.30	64
TAV FIRINI AKTUATOR VANA	1	2.60	26
TAV 4 SARTLANDIRICI KAVANOZ	1	2.60	26
TAV7 VALF BAGLANTI RAKORU	1	7.40	75
TAV8 SARTLANDIRICI	1	3.20	32
TAV10 AKTUATORLU VANA	1	1.60	16
TAV11 RAKOR KACAGI	1	5.30	53
TAV UST KURESEL VANA	1	4.80	48
SOGUK HADDE AKTUATORLU VANA	1	9.80	99
LEVHA PAKETLEME HAVA TAB	1	2.60	26
LEVHA PAKETLEME SARTLANDIRICI	1	1.90	19
MANUEL PAKETLEME HAVA TAB MAKARASI	1	12.60	127
HAVA TAB BAGLANTISI	1	5.30	53
HAMSU ODA YUMUSATMA SUYU ATIK HAT	1	4.80	48
HAMSU ODASI HAVA TABANCASI	1	6.80	69
FOLYO TAV FIRIN 5 POZISYONER GIRIS	1	1.10	11
FOLYO TAV FIRIN 6 POZISYONER	1	42.40	427
FOLYO TAV 10 AKTUATOR VALF	1	12.60	127
ARITMA AKTUATOR VANA	1	11.60	117

Location	Number of leaks	Leak losses(l/min)	Leak costs(EUR)
ARITMA SARTLANDRICI CIKISI A025V03	1	2.60	26
KOAGULASYON TANKI HAVA HORTUMU	1	9.80	99
ARITMA BOLGESI KISICI VALF CIKISI	1	3.40	34
ARITMA GAZ YIKAMA KULESI ONU VALF	1	3.10	31
BOYA HATTI YIKAMA SPRING AKTUATOR	3	156.80	1581
BOYA HATTI YIKAMA SOLENOID VALF	1	6.30	64
BOYA HATTI YIKAMA REGULATOR ALTI	1	2.60	26
BOYA HATTI YIKAMA VALF	1	7.40	75
BOYA HATTI YIKAMA REG VALF	1	5.80	58
BOYA HATTI YIKAMA UST SART UNITE	1	9.20	93
BOYA HAT UST KAT SART UNITESI	1	3.80	38

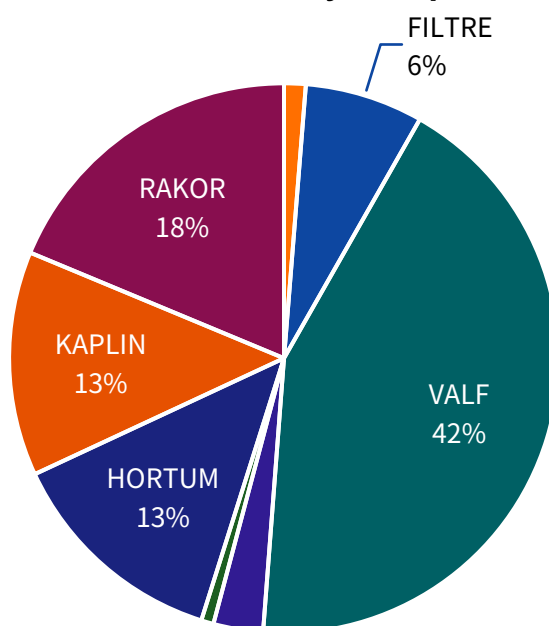
Leak losses by Group

Group	Number of leaks	Leak losses(l/min)	Leak costs(EUR)
MANOMETRE	4	6.80	69
FILTRE	8	37.20	375
VALF	15	229.80	2316
KAPLIN	6	15.60	157
PISTON	1	3.90	39
HORTUM	5	70.60	712
KAPLIN	6	70.60	712
RAKOR	11	100.10	1009

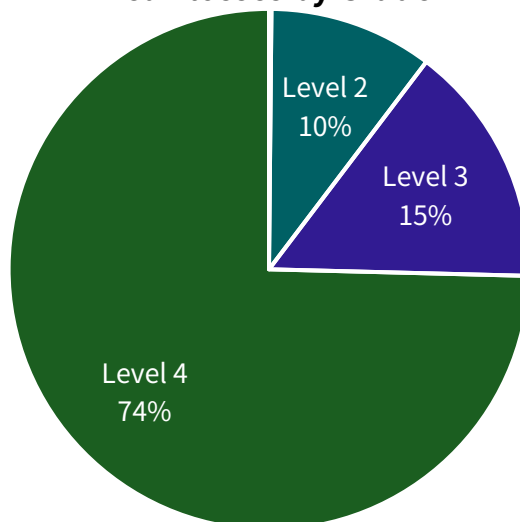
Leak losses by Grade

Grade Level	Number of leaks	Leak losses(l/min)	Leak costs(EUR)
Level 0	0	0.00	0
Level 1	2	0.80	8
Level 2	22	54.40	548
Level 3	14	80.60	812
Level 4	18	398.80	4020

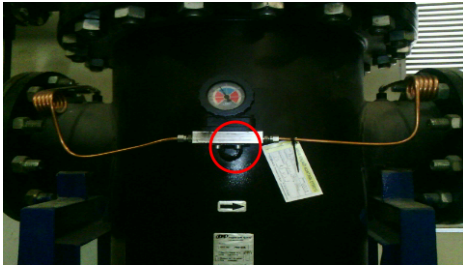
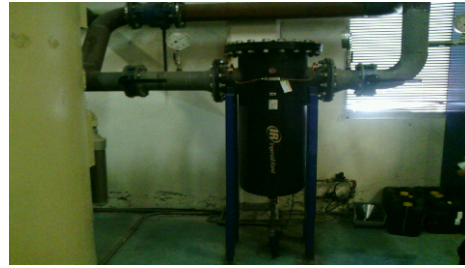
Tag	Leak Info	Losses
002	Location: KOMP DAIRESI Group: MANOMETRE Grade: 2 Distance: 200 cm Recorded: 2022-06-22	2.60 l/min 26 EUR/year Sound Level: 56 dB Pressure: 7.00 bar Last updated: 2022-06-28

Notes: KONTROL VE DEGİSİM ONERİLİR

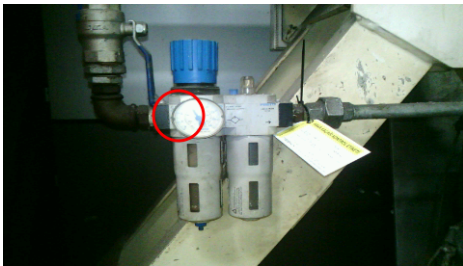
Tag	Leak Info	Losses
003	Location: TASLAMA MAK BESLEME Group: MANOMETRE Grade: 1 Distance: 100 cm Recorded: 2022-06-22	0.20 l/min 2 EUR/year Sound Level: 43 dB Pressure: 5.00 bar Last updated: 2022-06-28

Notes: SART GIRISI KONTROL

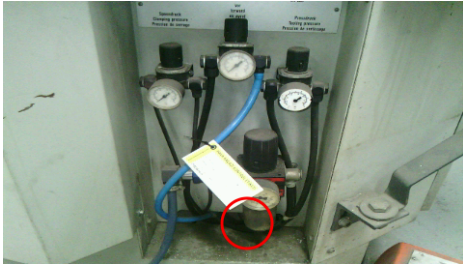
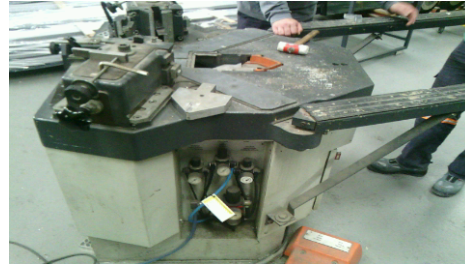
Tag	Leak Info	Losses
004	Location: TASLAMA PRES ELUMATEC Group: MANOMETRE Grade: 1 Distance: 200 cm Recorded: 2022-06-22	0.60 l/min 6 EUR/year
	Sound Level: 44 dB Pressure: 7.00 bar Last updated: 2022-06-28

Notes: FR ICIN KONTROL

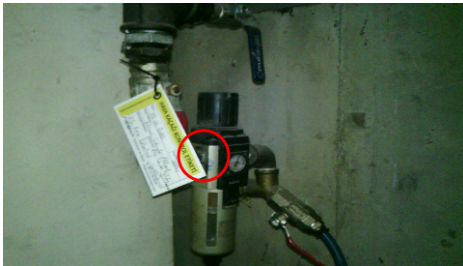
Tag	Leak Info	Losses
006	Location: FREZE SARTLANDIRICISI Group: FILTRE Grade: 2 Distance: 200 cm Recorded: 2022-06-22	2.60 l/min 26 EUR/year
	Sound Level: 56 dB Pressure: 7.00 bar Last updated: 2022-06-28

Notes: SARTLANDIRICI KONTROL VE DEGISIM

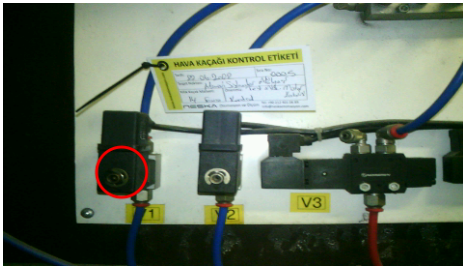
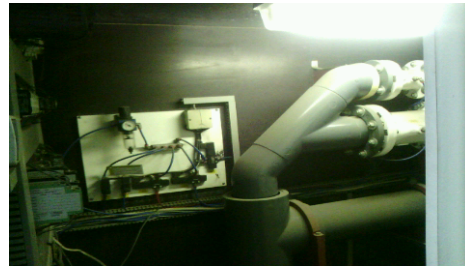
Tag	Leak Info	Losses
007	Location: TASLAMA TEST MAK MOTOR KABINI Group: VALF Grade: 2 Distance: 200 cm Recorded: 2022-06-22	1.50 l/min 15 EUR/year Sound Level: 51 dB Pressure: 7.00 bar Last updated: 2022-06-28

Notes: SOLENOID VALF KONTROL VE DEGISIM

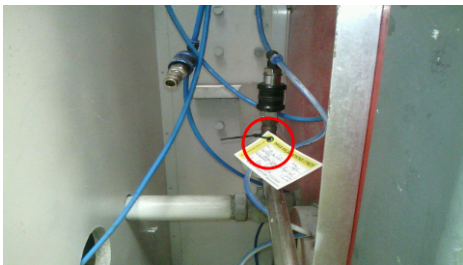
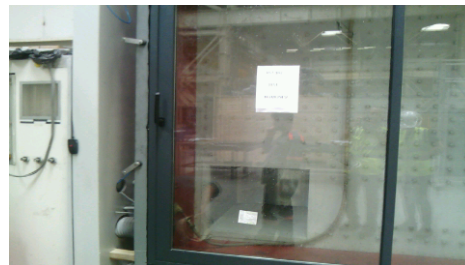
Tag	Leak Info	Losses
008	Location: TASLAMA TEST UNİTESİ PİSTON Group: KAPLIN Grade: 2 Distance: 200 cm Recorded: 2022-06-22	1.20 l/min 12 EUR/year Sound Level: 49 dB Pressure: 7.00 bar Last updated: 2022-06-28

Notes: PİSTON İCİN KONTROL VE DEĞİŞİM

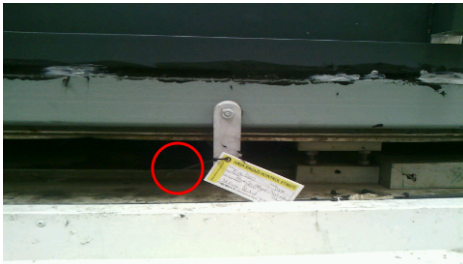
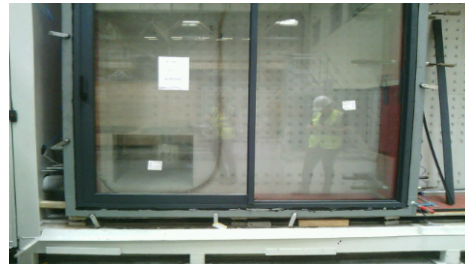
Tag	Leak Info	Losses
009	Location: TASLAMA TEST UNITESI PISTON Group: PISTON Grade: 2 Distance: 200 cm Recorded: 2022-06-22	3.90 l/min 39 EUR/year
	Sound Level: 52 dB Pressure: 7.00 bar Last updated: 2022-06-28

Notes: PISTONLAR ICIN KONTROL VE DEGISIM

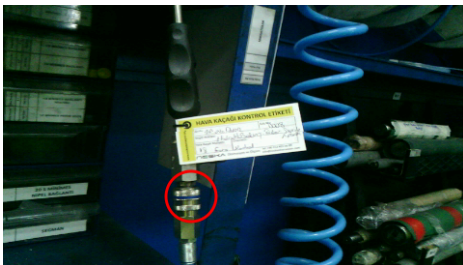
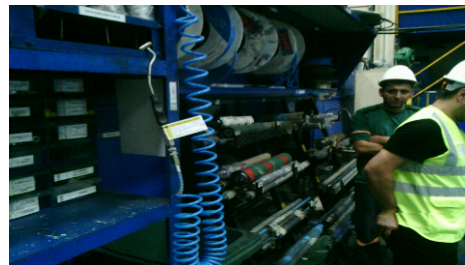
Tag	Leak Info	Losses
010	Location: HIDROLIK BAKIM TEKER SISIRME UNITE Group: KAPLIN Grade: 2 Distance: 200 cm Recorded: 2022-06-22	1.90 l/min 19 EUR/year
	Sound Level: 53 dB Pressure: 7.00 bar Last updated: 2022-06-28

Notes: KAPLIN BAGLANTI KONTROL VE DEGISIM

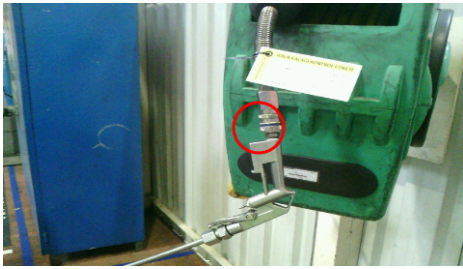
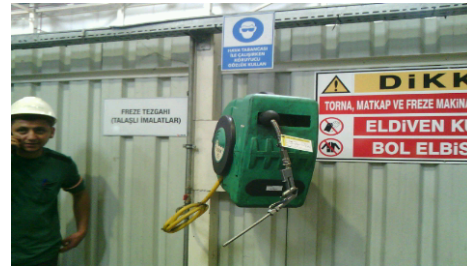
Tag	Leak Info	Losses
011	Location: HIDROLIK BAKIM TORNA ATOLYESI Group: KAPLIN Grade: 2 Distance: 200 cm Recorded: 2022-06-22	1.40 l/min 14 EUR/year Sound Level: 50 dB Pressure: 7.00 bar Last updated: 2022-06-28

Notes: FREZE TEZGAH HAVA TAB DEGISIM

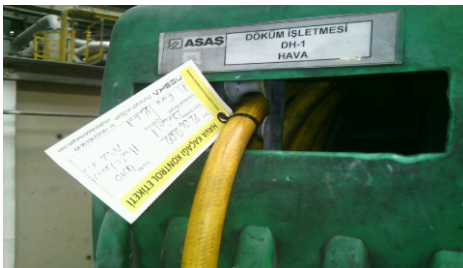
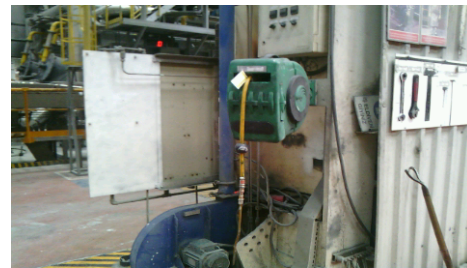
Tag	Leak Info	Losses
012	Location: DOKUM 1 HAVA TAB Group: HORTUM Grade: 4 Distance: 200 cm Recorded: 2022-06-22	9.00 l/min 91 EUR/year Sound Level: 69 dB Pressure: 7.00 bar Last updated: 2022-06-28

Notes: HAVA TAB KONTROL VE DEGISIM

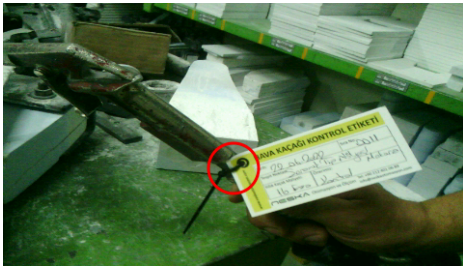
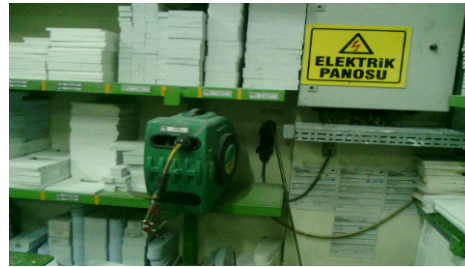
Tag	Leak Info	Losses
013	Location: SERAMİK ATOLYE HAVA TAB Group: KAPLIN Grade: 2 Distance: 200 cm Recorded: 2022-06-22	1.70 l/min 17 EUR/year Sound Level: 52 dB Pressure: 7.00 bar Last updated: 2022-06-28

Notes: HAVA TAB KONTROL VE DEĞİŞİM

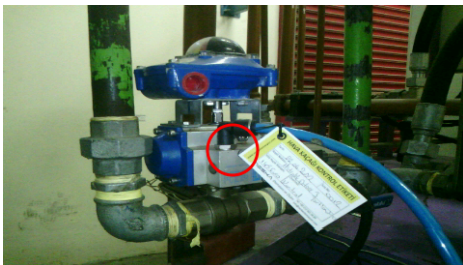
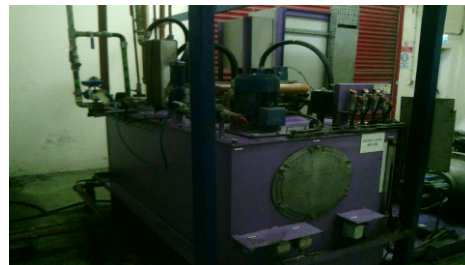
Tag	Leak Info	Losses
014	Location: HIDROLİK UNITE VALF Group: VALF Grade: 4 Distance: 200 cm Recorded: 2022-06-22	14.80 l/min 149 EUR/year Sound Level: 75 dB Pressure: 7.00 bar Last updated: 2022-06-28

Notes: VALF İÇİN KONTROL VE DEĞİŞİM

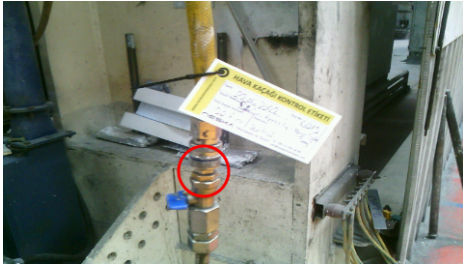
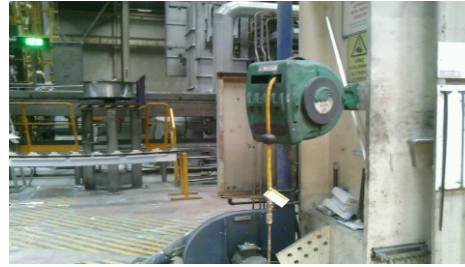
Tag	Leak Info	Losses
015	Location: DOKUM HATTI 4 HAVA TAB Group: KAPLIN Grade: 2 Distance: 200 cm Recorded: 2022-06-22	3.10 l/min 31 EUR/year Sound Level: 58 dB Pressure: 7.00 bar Last updated: 2022-06-28

Notes: KONTROL VE DEGISIM

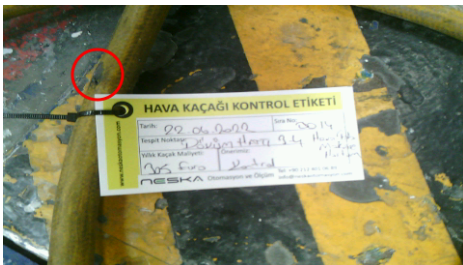
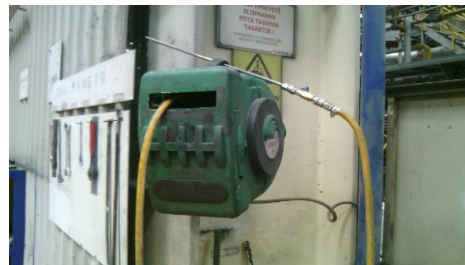
Tag	Leak Info	Losses
016	Location: DOKUM HATTI 4 HAVA TAB Group: HORTUM Grade: 4 Distance: 200 cm Recorded: 2022-06-22	31.00 l/min 312 EUR/year Sound Level: 83 dB Pressure: 7.00 bar Last updated: 2022-06-28

Notes: HORTUM DEGISIMI ONERILIR

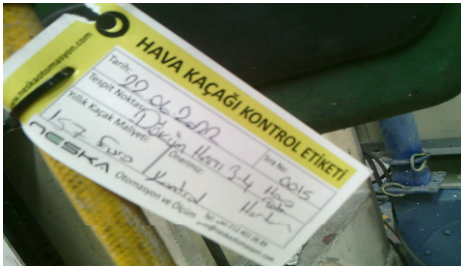
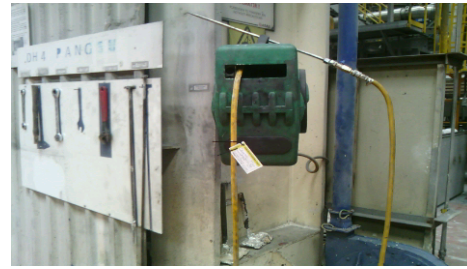
Tag	Leak Info	Losses
017	Location: DOKUM HATTI 4 HAVA TAB Group: HORTUM Grade: 4 Distance: 200 cm Recorded: 2022-06-22	16.00 l/min 161 EUR/year Sound Level: 76 dB Pressure: 7.00 bar Last updated: 2022-06-28

Notes: HORTUM DEGISIMI ONERILIR

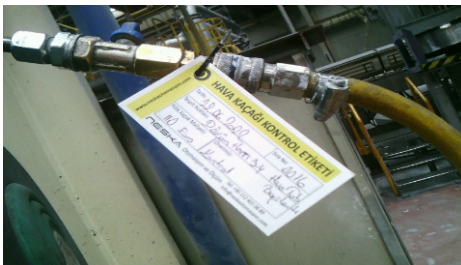
Tag	Leak Info	Losses
019	Location: DOKUM HATTI 4 HAVA TAB Group: KAPLIN Grade: 4 Distance: 200 cm Recorded: 2022-06-22	11.20 l/min 113 EUR/year Sound Level: 62 dB Pressure: 7.00 bar Last updated: 2022-06-28

Notes: KONTROL VE DEGISIM

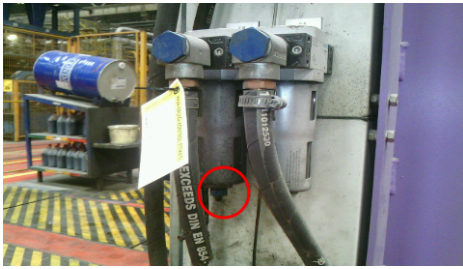
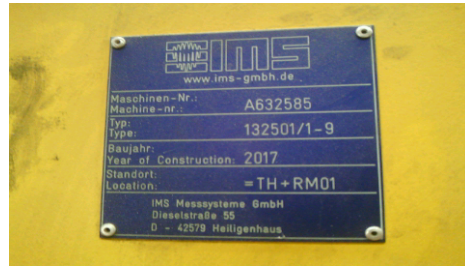
Tag	Leak Info	Losses
020	Location: DK5 FILTRE ALT TAHLIYE Group: FILTRE Grade: 3 Distance: 200 cm Recorded: 2022-06-22	6.30 l/min 64 EUR/year
	Sound Level: 66 dB Pressure: 7.00 bar Last updated: 2022-06-28

Notes: DEGISIM ONERILIR

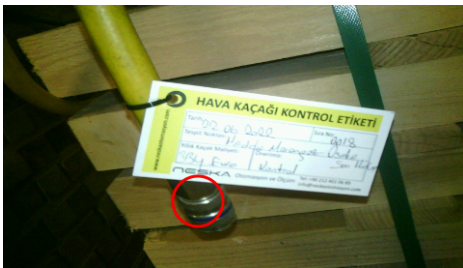
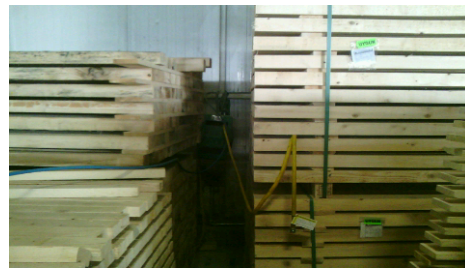
Tag	Leak Info	Losses
021	Location: HADDE MARANGOZ Group: KAPLIN Grade: 4 Distance: 200 cm Recorded: 2022-06-22	34.00 l/min 343 EUR/year
	Sound Level: 74 dB Pressure: 7.00 bar Last updated: 2022-06-28

Notes: KONTROL VE DEGISIM

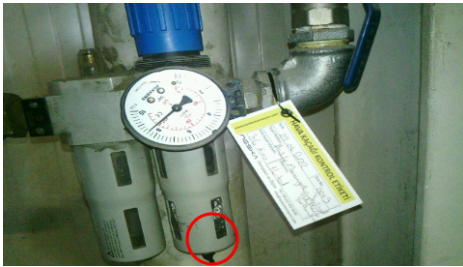
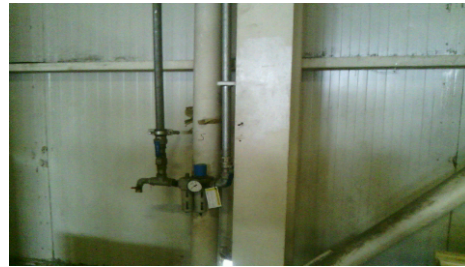
Tag	Leak Info	Losses
023	Location: HADDE MARANGOZ Group: FILTRE Grade: 4 Distance: 200 cm Recorded: 2022-06-22	9.00 l/min 91 EUR/year
	Sound Level: 69 dB Pressure: 7.00 bar Last updated: 2022-06-28

Notes: DEGİSİM ONERİLİR

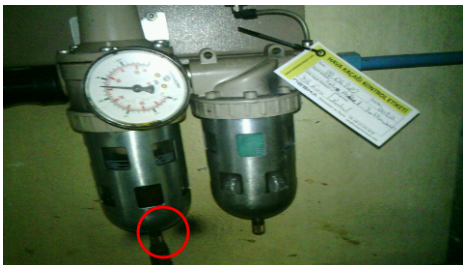
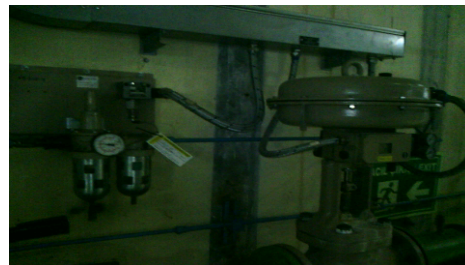
Tag	Leak Info	Losses
024	Location: HADDE SARTLANDIRICI ALTI Group: FILTRE Grade: 4 Distance: 200 cm Recorded: 2022-06-22	9.00 l/min 91 EUR/year
	Sound Level: 69 dB Pressure: 7.00 bar Last updated: 2022-06-28

Notes: DEGİSİM ONERİLİR

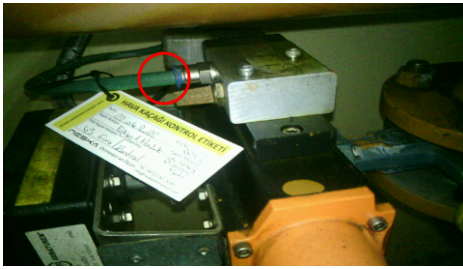
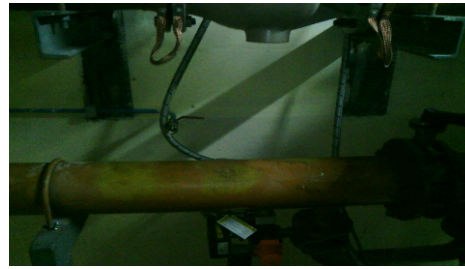
Tag	Leak Info	Losses
025	Location: FOLYO HADDE1 RAKOR BAĞLANTI Group: RAKOR Grade: 3 Distance: 200 cm Recorded: 2022-06-22	4.40 l/min 44 EUR/year
	Sound Level: 62 dB Pressure: 7.00 bar Last updated: 2022-06-28

Notes: İLGİLİ URUNLER ICIN DEGISIM ONERILIR

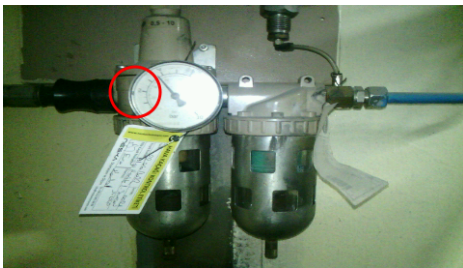
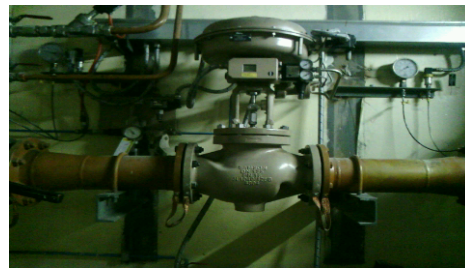
Tag	Leak Info	Losses
026	Location: FOLYO HADDE 1 Group: MANOMETRE Grade: 2 Distance: 200 cm Recorded: 2022-06-22	3.40 l/min 34 EUR/year
	Sound Level: 59 dB Pressure: 7.00 bar Last updated: 2022-06-28

Notes: KONTROL VE DEGISIM ONERILIR

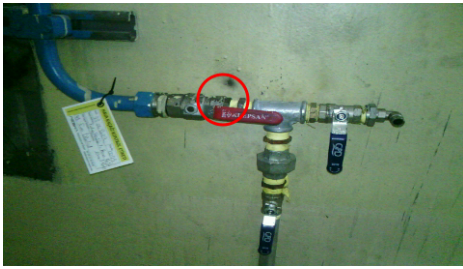
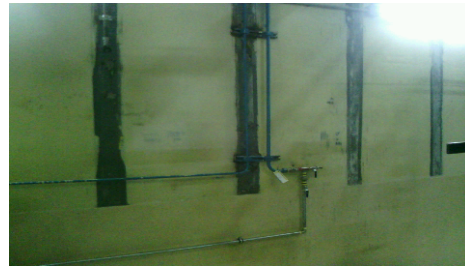
Tag	Leak Info	Losses
027	Location: FOLYO HADDE1 HAVA HATTI Group: KAPLIN Grade: 3 Distance: 200 cm Recorded: 2022-06-22	4.40 l/min 44 EUR/year Sound Level: 62 dB Pressure: 7.00 bar Last updated: 2022-06-28

Notes: DEGİSİM ONERİLİR

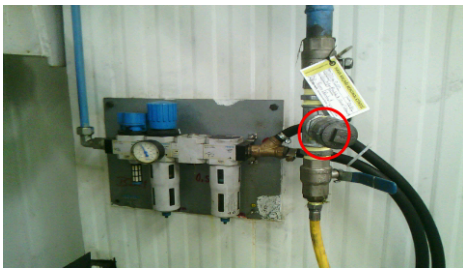
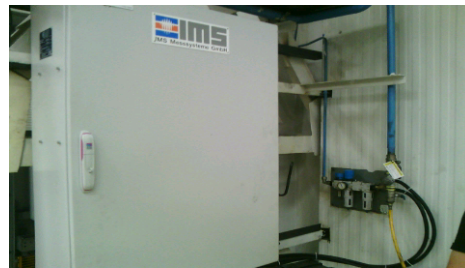
Tag	Leak Info	Losses
028	Location: FOLYO HADDE 1 T BAGLANTI Group: RAKOR Grade: 3 Distance: 200 cm Recorded: 2022-06-22	5.30 l/min 53 EUR/year Sound Level: 64 dB Pressure: 7.00 bar Last updated: 2022-06-28

Notes: KONTROL VE DEĞİSİM ONERİLİR

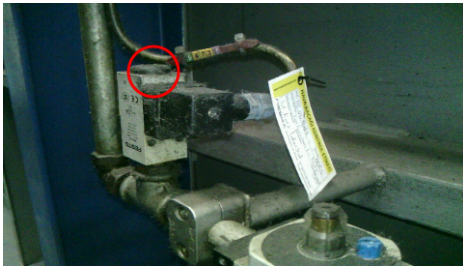
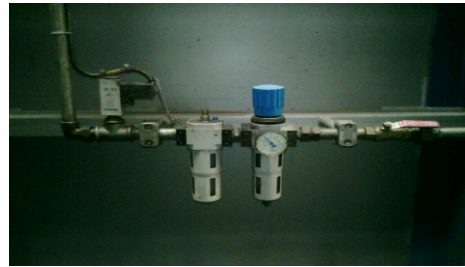
Tag	Leak Info	Losses
029	Location: TAV FIRINLARI SOLENOID VALF Group: VALF Grade: 3 Distance: 200 cm Recorded: 2022-06-23	6.30 l/min 64 EUR/year Sound Level: 66 dB Pressure: 7.00 bar Last updated: 2022-06-28

Notes: KONTROL VE DEGİSİM ONERİLİR

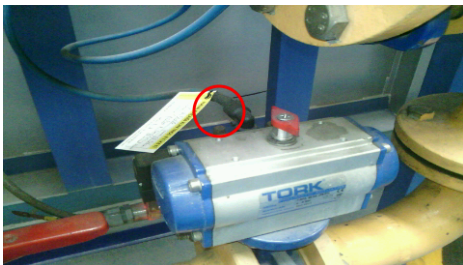
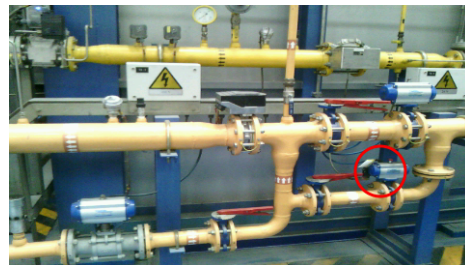
Tag	Leak Info	Losses
030	Location: TAV FIRINI AKTUATOR VANA Group: RAKOR Grade: 2 Distance: 200 cm Recorded: 2022-06-23	2.60 l/min 26 EUR/year Sound Level: 56 dB Pressure: 7.00 bar Last updated: 2022-06-28

Notes: KONTROL VE DEGİSİM ONERİLİR

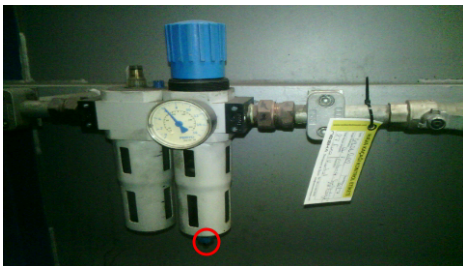
Tag	Leak Info	Losses
031	Location: TAV 4 SARTLANDIRICI KAVANOZ Group: FILTRE Grade: 2 Distance: 200 cm Recorded: 2022-06-23	2.60 l/min 26 EUR/year Sound Level: 56 dB Pressure: 7.00 bar Last updated: 2022-06-28

Notes: ~~S~~ARTLANDIRICI DE~~S~~İM

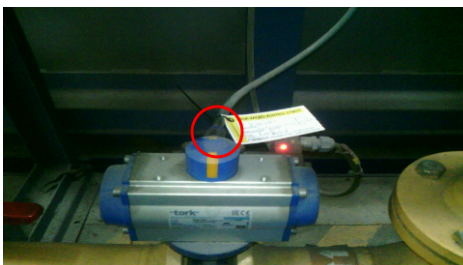
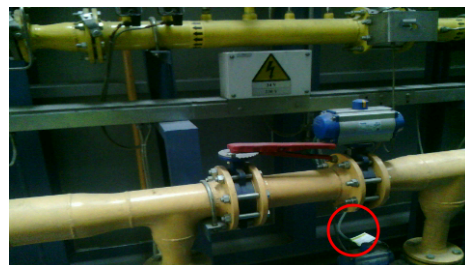
Tag	Leak Info	Losses
032	Location: TAV7 VALF BAGLANTI RAKORU Group: RAKOR Grade: 3 Distance: 200 cm Recorded: 2022-06-23	7.40 l/min 75 EUR/year Sound Level: 68 dB Pressure: 7.00 bar Last updated: 2022-06-28

Notes: AKTUATOR VANA CIN KONTROL VE DEGİSİM

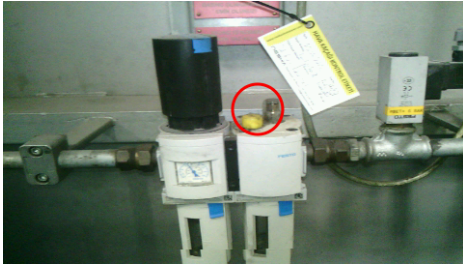
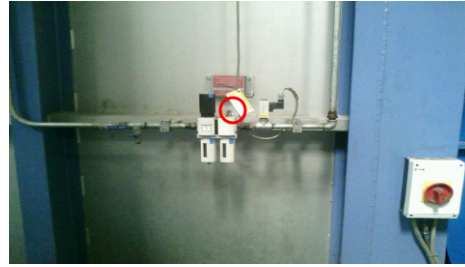
Tag	Leak Info	Losses
033	Location: TAV8 SARTLANDIRICI Group: FİLTRE Grade: 2 Distance: 300 cm Recorded: 2022-06-23	3.20 l/min 32 EUR/year
	Sound Level: 54 dB Pressure: 7.00 bar Last updated: 2022-06-28

Notes: KONTROL VE DEĞİŞİM ÖNERİLİR

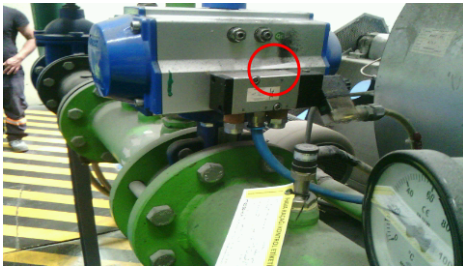
Tag	Leak Info	Losses
035	Location: TAV10 AKTUATORLU VANA Group: VALF Grade: 2 Distance: 300 cm Recorded: 2022-06-23	1.60 l/min 16 EUR/year
	Sound Level: 47 dB Pressure: 7.00 bar Last updated: 2022-06-28

Notes: KONTROL VE DEĞİŞİM ÖNERİLİR

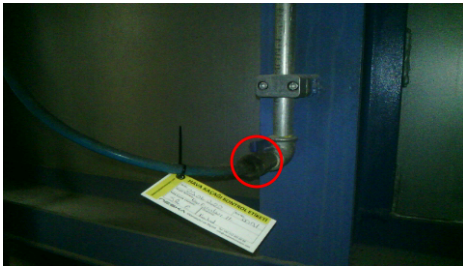
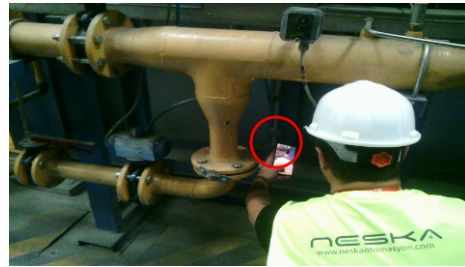
Tag	Leak Info	Losses
036	Location: TAV11 RAKOR KACAGI Group: RAKOR Grade: 3 Distance: 200 cm Recorded: 2022-06-23	5.30 l/min 53 EUR/year
	Sound Level: 64 dB Pressure: 7.00 bar Last updated: 2022-06-28

Notes: KONTROL VE DEGİSİM ONERİLİR

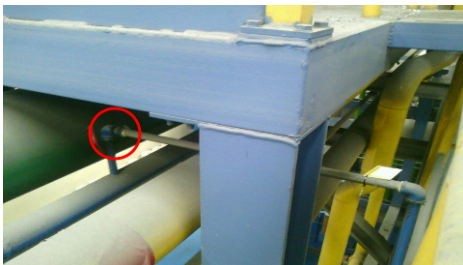
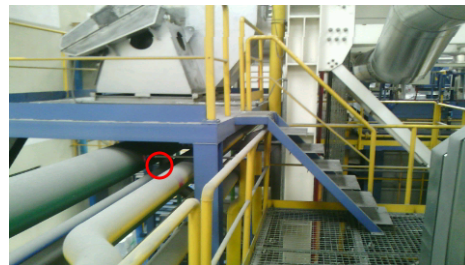
Tag	Leak Info	Losses
037	Location: TAV UST KURESEL VANA Group: HORTUM Grade: 3 Distance: 200 cm Recorded: 2022-06-23	4.80 l/min 48 EUR/year
	Sound Level: 63 dB Pressure: 7.00 bar Last updated: 2022-06-28

Notes: KONTROL VE DEGİSİM ONERİLİR

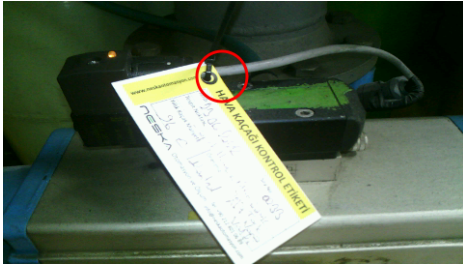
Tag	Leak Info	Losses
038	Location: SOGUK HADDE AKTUATORLU VANA Group: VALF Grade: 4 Distance: 200 cm Recorded: 2022-06-23	9.80 l/min 99 EUR/year Sound Level: 70 dB Pressure: 7.00 bar Last updated: 2022-06-28

Notes: FILTRE ODASI VALF KONTROL VE DEGISIM

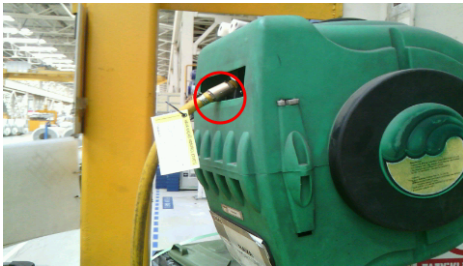
Tag	Leak Info	Losses
039	Location: LEVHA PAKETLEME HAVA TAB Group: KAPLIN Grade: 2 Distance: 200 cm Recorded: 2022-06-23	2.60 l/min 26 EUR/year Sound Level: 56 dB Pressure: 7.00 bar Last updated: 2022-06-28

Notes: KONTROL VE DEGISIM ONERILIR

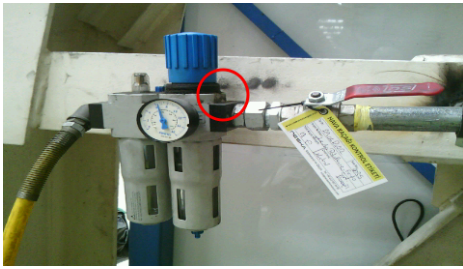
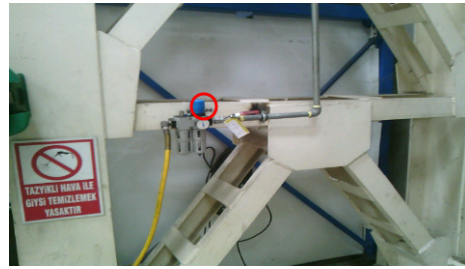
Tag	Leak Info	Losses
040	Location: LEVHA PAKETLEME SARTLANDIRICI Group: FILTRE Grade: 2 Distance: 200 cm Recorded: 2022-06-23	1.90 l/min 19 EUR/year Sound Level: 53 dB Pressure: 7.00 bar Last updated: 2022-06-28

Notes: FILTRE REGULATOR DEGISIM

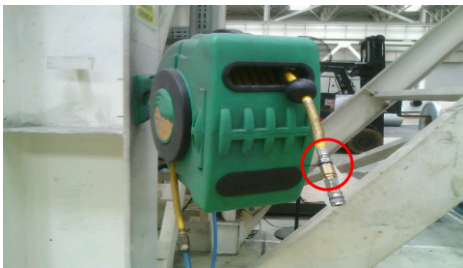
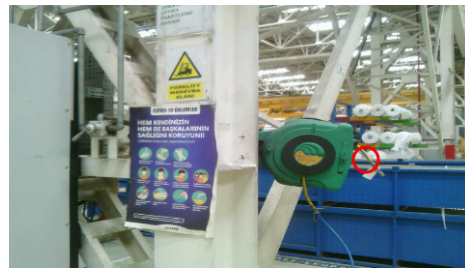
Tag	Leak Info	Losses
041	Location: MANUEL PAKETLEME HAVA TAB MAKARASI Group: KAPLIN Grade: 4 Distance: 200 cm Recorded: 2022-06-23	12.60 l/min 127 EUR/year Sound Level: 73 dB Pressure: 7.00 bar Last updated: 2022-06-28

Notes: KONTROL VE DEGISIM ONERILIR

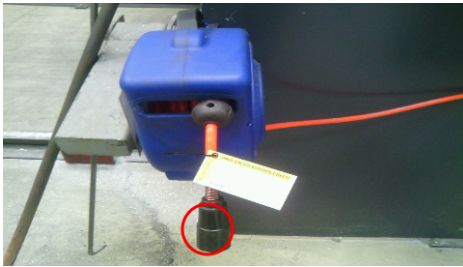
Tag	Leak Info	Losses
042	Location: HAVA TAB BAGLANTISI Group: KAPLIN Grade: 3 Distance: 200 cm Recorded: 2022-06-23	5.30 l/min 53 EUR/year Sound Level: 64 dB Pressure: 7.00 bar Last updated: 2022-06-28

Notes: KONTROL VE DEGİSİM ONERİLİR

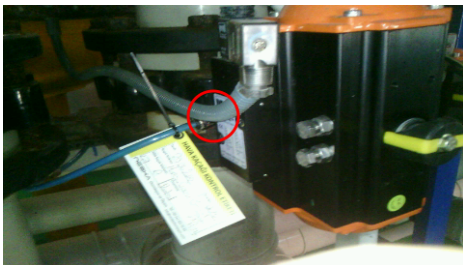
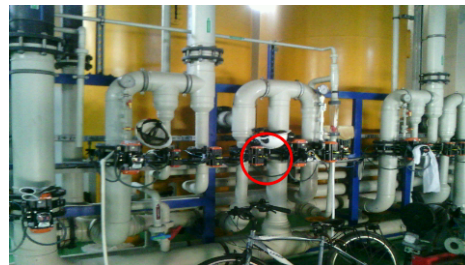
Tag	Leak Info	Losses
043	Location: HAMSU ODA YUMUSATMA SUYU ATIK HAT Group: RAKOR Grade: 3 Distance: 200 cm Recorded: 2022-06-23	4.80 l/min 48 EUR/year Sound Level: 63 dB Pressure: 7.00 bar Last updated: 2022-06-28

Notes: KONTROL VE DEGİSİM ONERİLİR

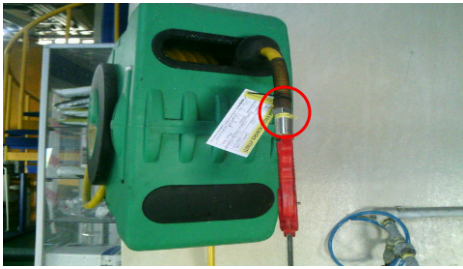
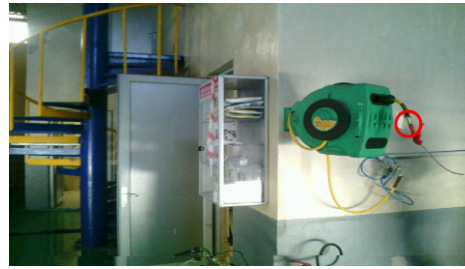
Tag	Leak Info	Losses
044	Location: HAMSU ODASI HAVA TABANCASI Group: KAPLIN Grade: 3 Distance: 200 cm Recorded: 2022-06-23	6.80 l/min 69 EUR/year Sound Level: 67 dB Pressure: 7.00 bar Last updated: 2022-06-28

Notes: KONTROL VE DEGİSİM ONERİLİR

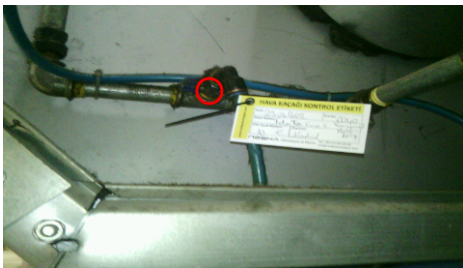
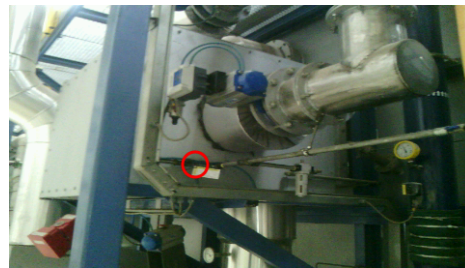
Tag	Leak Info	Losses
045	Location: FOLYO TAV FIRIN 5 POZİSYONER GİRİS Group: RAKOR Grade: 2 Distance: 200 cm Recorded: 2022-06-23	1.10 l/min 11 EUR/year Sound Level: 48 dB Pressure: 7.00 bar Last updated: 2022-06-28

Notes: KONTROL VE DEGİSİM ONERİLİR

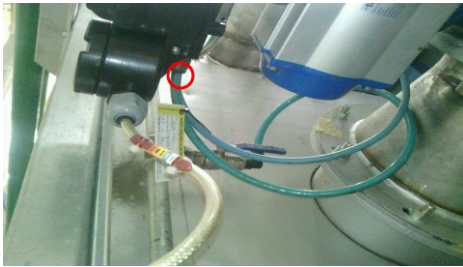
Tag	Leak Info	Losses
046	Location: FOLYO TAV FIRIN 6 POZISYONER Group: RAKOR Grade: 4 Distance: 200 cm Recorded: 2022-06-23	42.40 l/min 427 EUR/year Sound Level: 87 dB Pressure: 7.00 bar Last updated: 2022-06-28

Notes: KONTROL VE DEGİSİM ONERİLİR

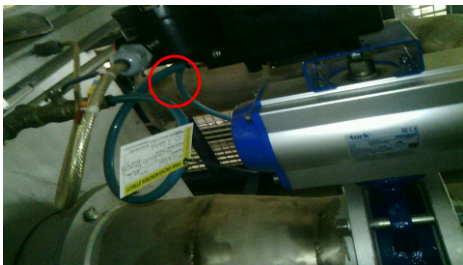
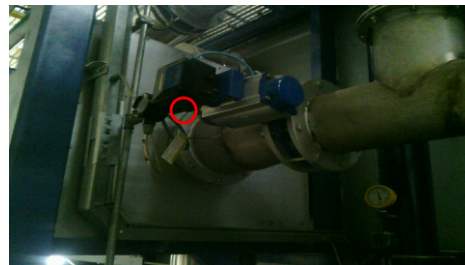
Tag	Leak Info	Losses
047	Location: FOLYO TAV 10 AKTUATOR VALF Group: RAKOR Grade: 4 Distance: 200 cm Recorded: 2022-06-23	12.60 l/min 127 EUR/year Sound Level: 73 dB Pressure: 7.00 bar Last updated: 2022-06-28

Notes: KONTROL VE DEGİSİM ONERİLİR

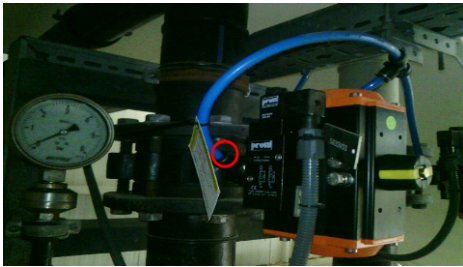
Tag	Leak Info	Losses
048	Location: ARITMA AKTUATOR VANA Group: RAKOR Grade: 4 Distance: 200 cm Recorded: 2022-06-23	11.60 l/min 117 EUR/year Sound Level: 72 dB Pressure: 7.00 bar Last updated: 2022-06-28

Notes: KONTROL VE DEGİSİM ONERİLİR

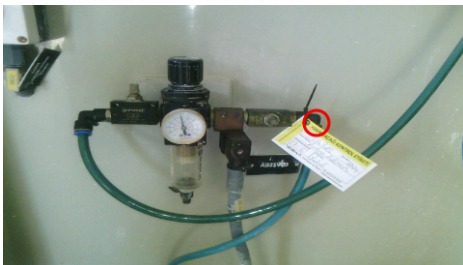
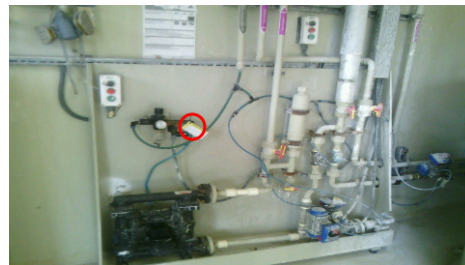
Tag	Leak Info	Losses
049	Location: ARITMA SARTLANDRICI ÇIKIŞI A025V03 Group: RAKOR Grade: 2 Distance: 200 cm Recorded: 2022-06-23	2.60 l/min 26 EUR/year Sound Level: 56 dB Pressure: 7.00 bar Last updated: 2022-06-28

Notes: KONTROL VE DEGİSİM ONERİLİR

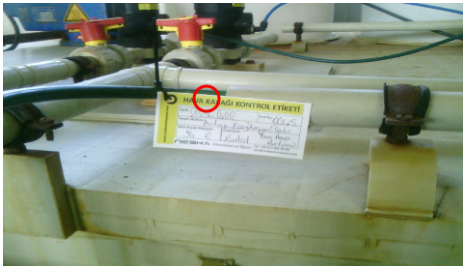
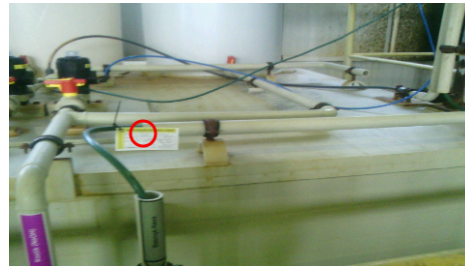
Tag	Leak Info	Losses
050	Location: KOAGULASYON TANKI HAVA HORTUMU Group: HORTUM Grade: 4 Distance: 200 cm Recorded: 2022-06-23	9.80 l/min 99 EUR/year Sound Level: 70 dB Pressure: 7.00 bar Last updated: 2022-06-28

Notes: KONTROL VE DEGİSİM ONERİLİR

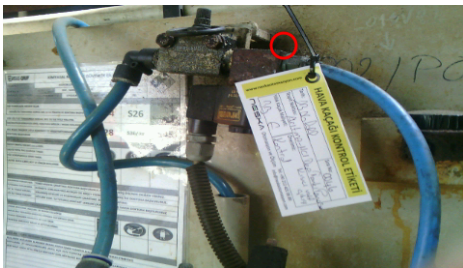
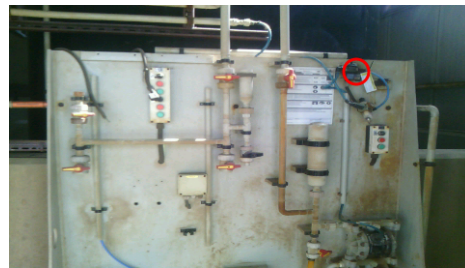
Tag	Leak Info	Losses
052	Location: ARITMA BOLGESI KISICI VALF ÇIKISI Group: VALF Grade: 2 Distance: 200 cm Recorded: 2022-06-23	3.40 l/min 34 EUR/year Sound Level: 59 dB Pressure: 7.00 bar Last updated: 2022-06-28

Notes: KONTROL VE DEGİSİM ONERİLİR

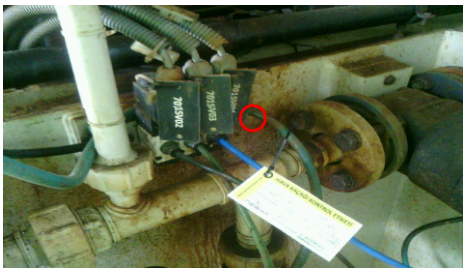
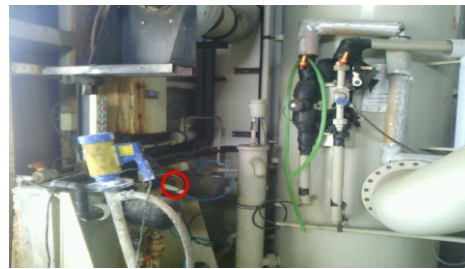
Tag	Leak Info	Losses
053	Location: ARITMA GAZ YIKAMA KULESI ONU VALF Group: VALF Grade: 2 Distance: 200 cm Recorded: 2022-06-23	3.10 l/min 31 EUR/year Sound Level: 58 dB Pressure: 7.00 bar Last updated: 2022-06-28

Notes: KONTROL VE DEGİSİM ONERİLİR

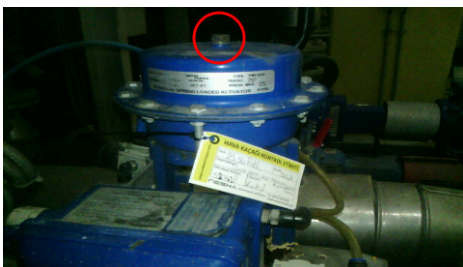
Tag	Leak Info	Losses
054	Location: BOYA HATTI YIKAMA SPRING AKTUATOR Group: VALF Grade: 4 Distance: 200 cm Recorded: 2022-06-24	53.60 l/min 540 EUR/year Sound Level: 90 dB Pressure: 7.00 bar Last updated: 2022-06-28

Notes: DEGİSİM ONERİLİR

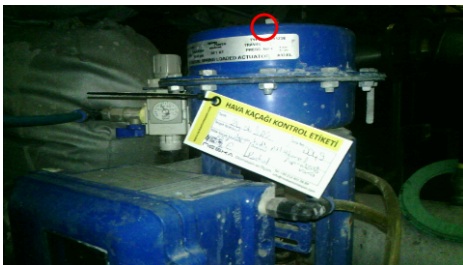
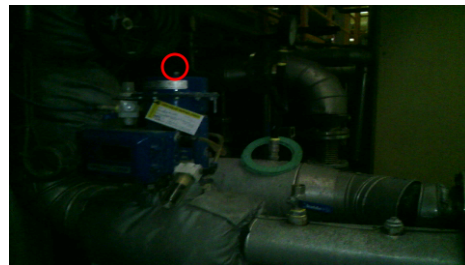
Tag	Leak Info	Losses
056	Location: BOYA HATTI YIKAMA SPRING AKTUATOR Group: VALF Grade: 4 Distance: 200 cm Recorded: 2022-06-24	53.60 l/min 540 EUR/year Sound Level: 90 dB Pressure: 7.00 bar Last updated: 2022-06-28

Notes: KONTROL VE DEGİSİM ONERİLİR

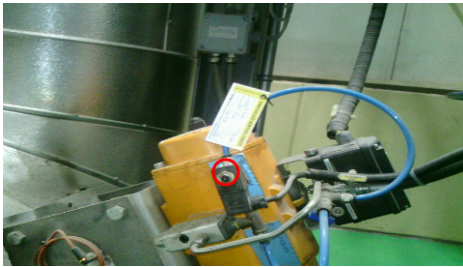
Tag	Leak Info	Losses
057	Location: BOYA HATTI YIKAMA SOLENOID VALF Group: VALF Grade: 3 Distance: 200 cm Recorded: 2022-06-24	6.30 l/min 64 EUR/year Sound Level: 66 dB Pressure: 7.00 bar Last updated: 2022-06-28

Notes: KONTROL VE DEGİSİM ONERİLİR

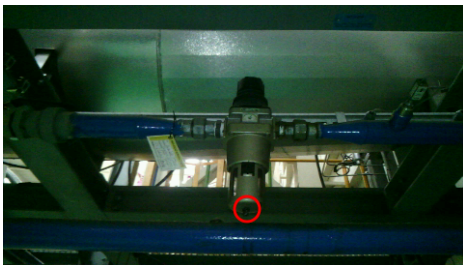
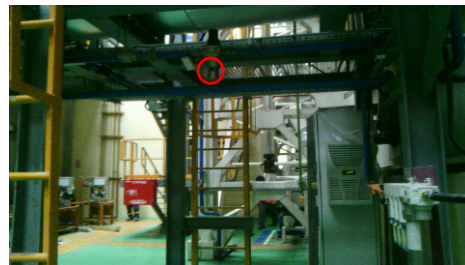
Tag	Leak Info	Losses
058	Location: BOYA HATTI YIKAMA REGULATOR ALTI Group: FİLTRE Grade: 2 Distance: 200 cm Recorded: 2022-06-24	2.60 l/min 26 EUR/year Sound Level: 56 dB Pressure: 7.00 bar Last updated: 2022-06-28

Notes: KONTROL VE DEGİSİM ONERİLİR

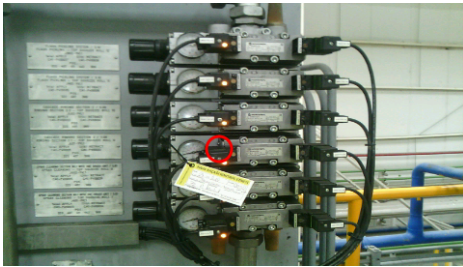
Tag	Leak Info	Losses
060	Location: BOYA HATTI YIKAMA VALF Group: VALF Grade: 3 Distance: 200 cm Recorded: 2022-06-24	7.40 l/min 75 EUR/year
	Sound Level: 68 dB Pressure: 7.00 bar Last updated: 2022-06-28

Notes: KONTROL VE DEGİSİM ONERİLİR

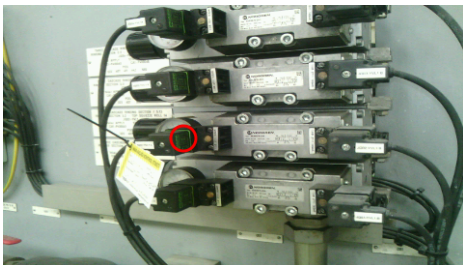
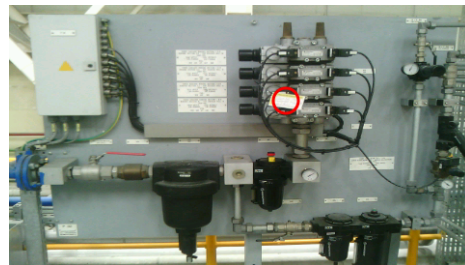
Tag	Leak Info	Losses
061	Location: BOYA HATTI YIKAMA REG VALF Group: VALF Grade: 3 Distance: 200 cm Recorded: 2022-06-24	5.80 l/min 58 EUR/year
	Sound Level: 56 dB Pressure: 7.00 bar Last updated: 2022-06-28

Notes: KONTROL VE DEGİSİM ONERİLİR

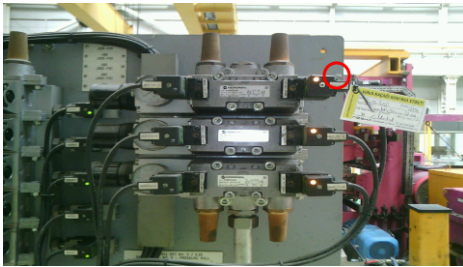
Tag	Leak Info	Losses
062	Location: BOYA HATTI YIKAMA UST SART UNITE Group: VALF Grade: 4 Distance: 200 cm Recorded: 2022-06-24	9.20 l/min 93 EUR/year Sound Level: 69 dB Pressure: 6.00 bar Last updated: 2022-06-28

Notes: KONTROL VE DEGISIM ONERILIR

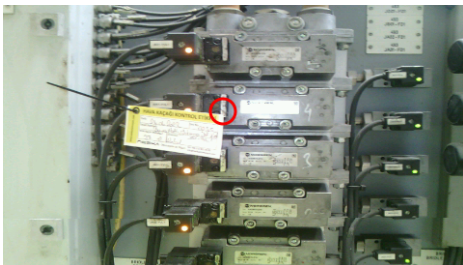
Tag	Leak Info	Losses
063	Location: BOYA HAT UST KAT SART UNITESI Group: VALF Grade: 2 Distance: 200 cm Recorded: 2022-06-24	3.80 l/min 38 EUR/year Sound Level: 60 dB Pressure: 6.00 bar Last updated: 2022-06-28

Notes: KONTROL VE DEGISIM ONERILIR
